Home Inspection Report

Address: Sample Report

Inspection Date : 2021

Assured Home Services, LLC

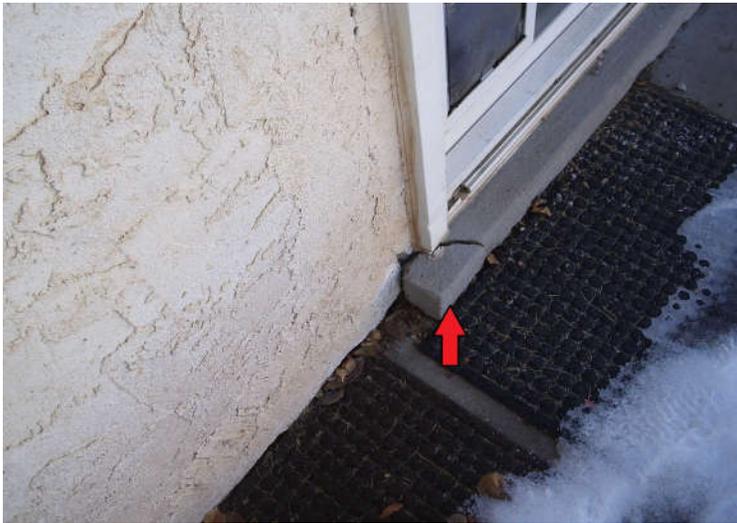
Improve: The concrete threshold for the glass sliding door near the dining room is cracked at the west corner. **Photo 1.** I recommend that you contact a qualified contractor to determine the proper corrective measures.

1 The concrete curb is damaged at the glass sliding door in the back.

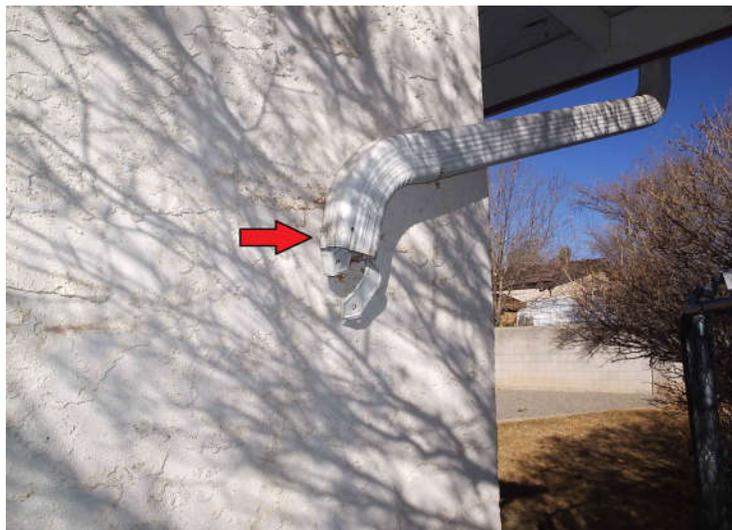
Improve: The down spouts should be extended so that they are directing the rain water at least three feet from the foundation of the house. **Photo 2.**

2 The down spout should be extended farther from the house.

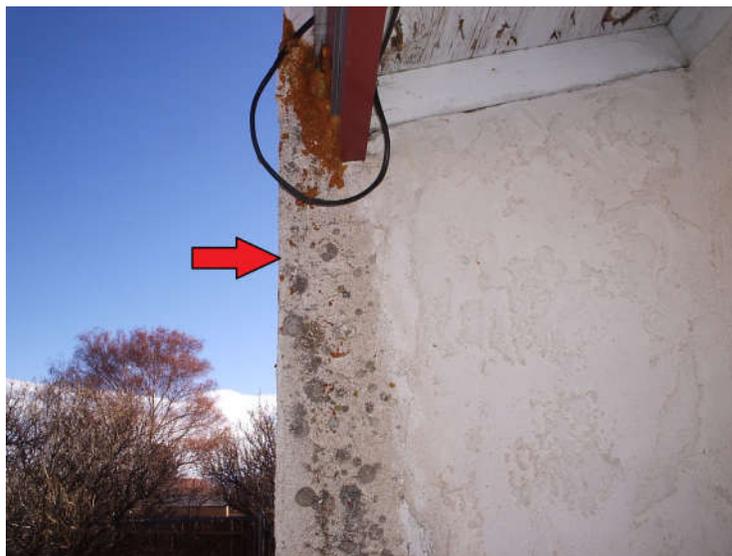
Improve: The flashing at the bottom of the fireplace is allowing some water to drip down the face of the stucco. This is causing the stucco to stain. **Photo 3.** Installing the flashing under the stucco will help to keep the water moving away from the chimney edges. **Photo 4.** I recommend that you contact a qualified contractor to determine the proper corrective measures.

3 The stucco is stained from water draining down the face.

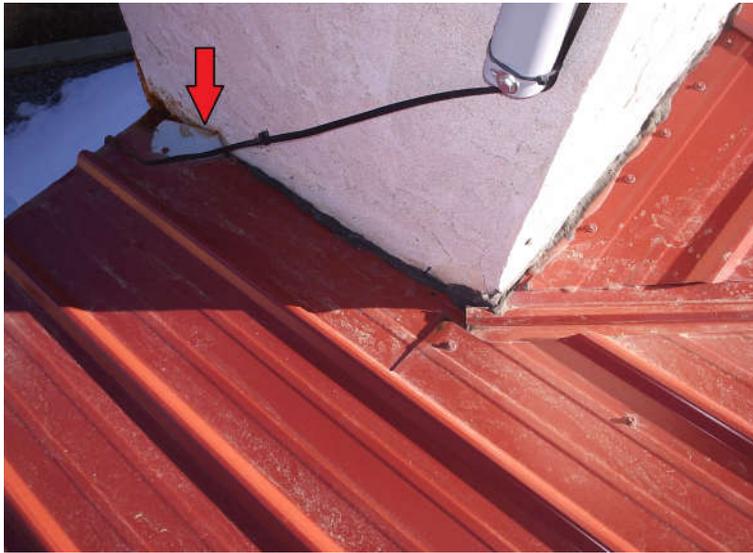
4 The flashing at the base of the chimney should be under the stucco for proper drainage.

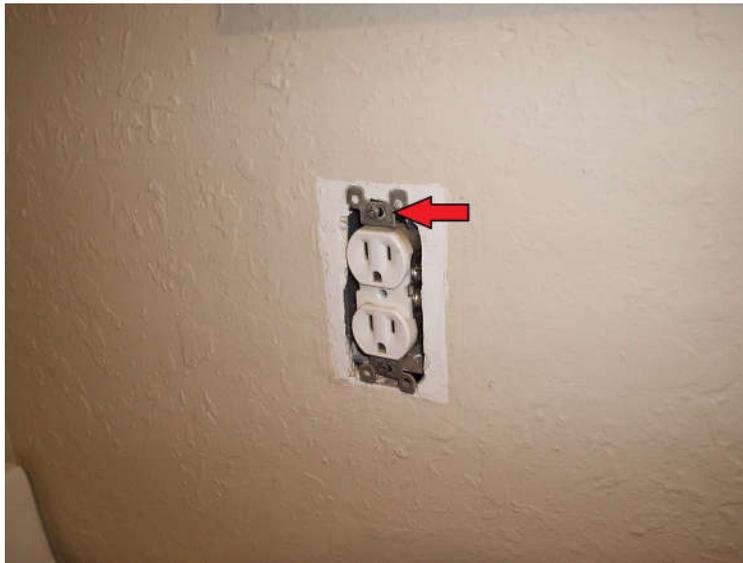
I did examine a few of the outlets inside the house. Most of the ones are the proper CO/ALR type of receptacles and switches. **Photo 5.** A few of the newer white receptacles in Bedroom Four are copper only, and are connected to the aluminum wiring. **Photo 6.** These receptacles should be replaced with the proper type.

5 The majority of the outlets are the proper CO/ALR type. This is where it will be stamped.

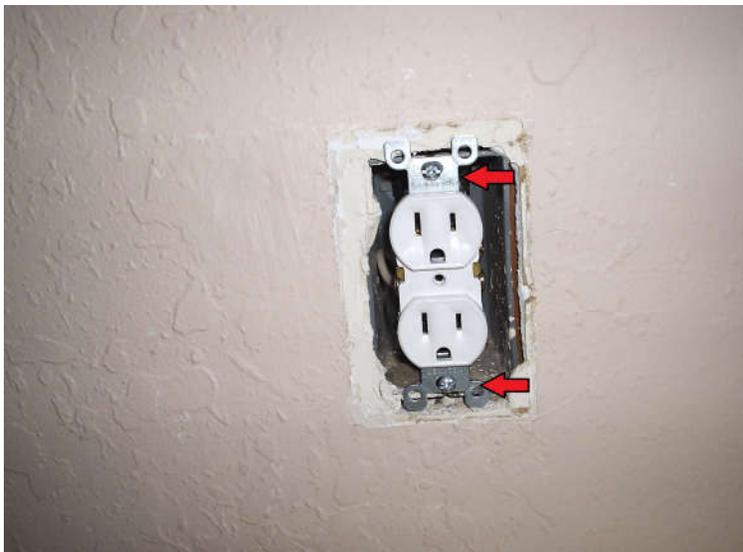
I did examine a few of the outlets inside the house. Most of the ones are the proper CO/ALR type of receptacles and switches. **Photo 5.** A few of the newer white receptacles in Bedroom Four are copper only, and are connected to the aluminum wiring. **Photo 6.** These receptacles should be replaced with the proper type.

6 The receptacles in Bedroom Four are not the proper CO/ALR type.

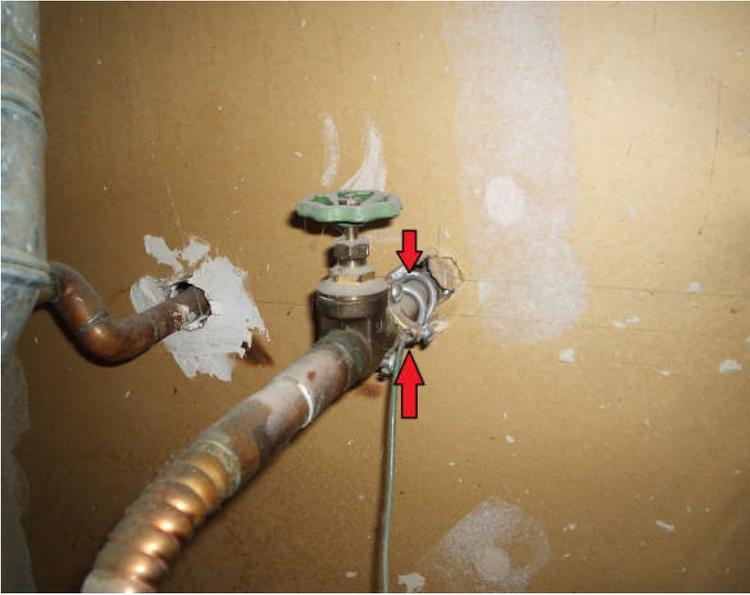
4: The copper water lines did not appear to be bonded to the ground system. There is normally a bonding wire between the water lines and the ground system connected above the water heater or near the shut off valve for the system. The bonding wire is present, but it is not connected to the bonding clamp. **Photo 7.**

7 The large aluminum bonding wire should be installed into the clamp.

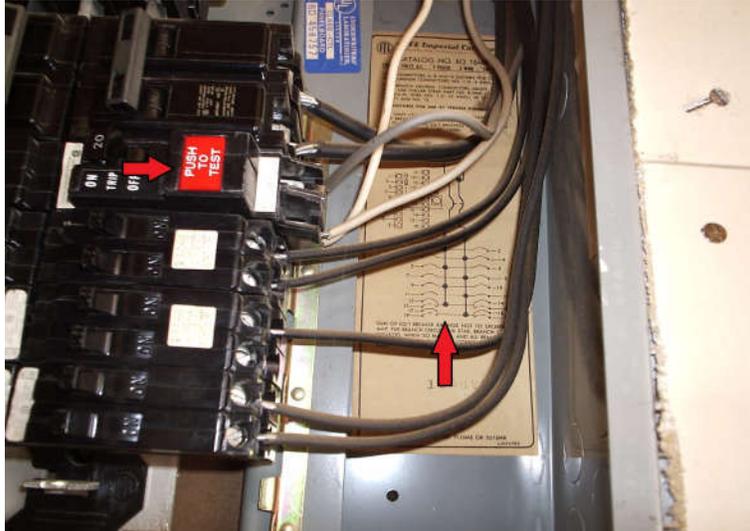
5: According to the manufacturer's instructions, the tandem breakers (2 per space) should not be installed above the bottom four spaces (2 per side) according to the diagram. **Photo 8.** The tandem breakers should be moved to the lower four spaces, and the proper single space breakers installed above the tandem breakers. **Photo 9.**

8 The manufacturer's instructions indicate that the tandem breakers should be in the lower four breaker slots.

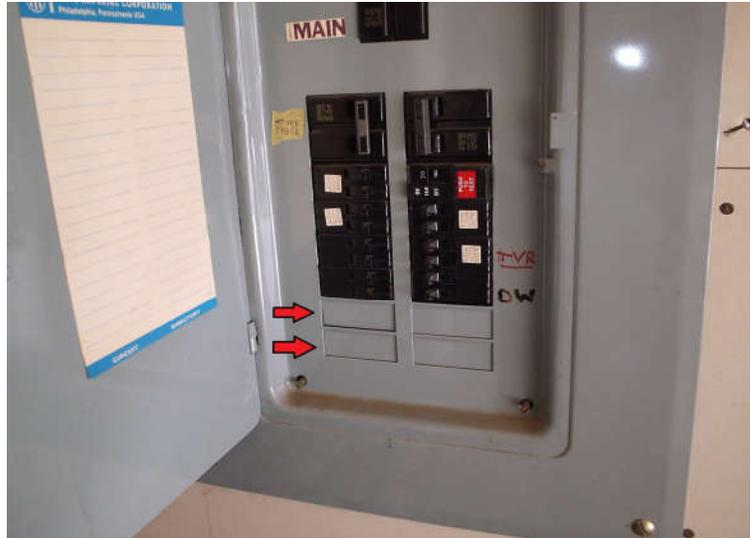
9 These lower four spots should have the tandem breakers.

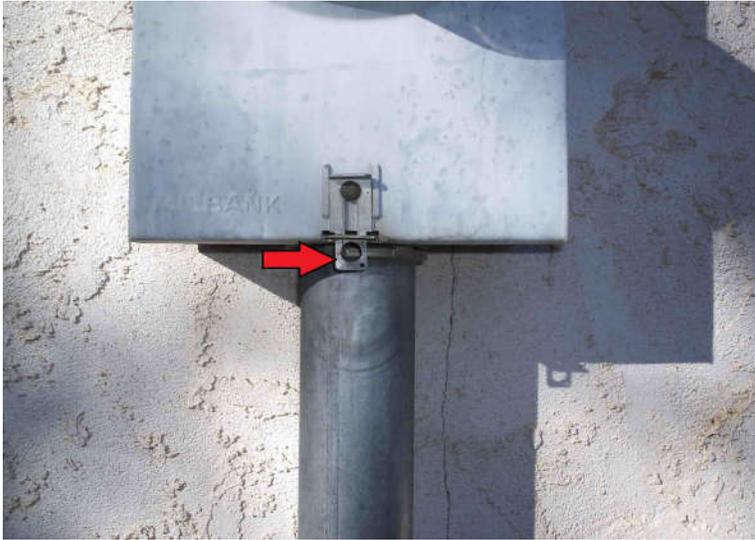
10 The county seal is not present on the meter.

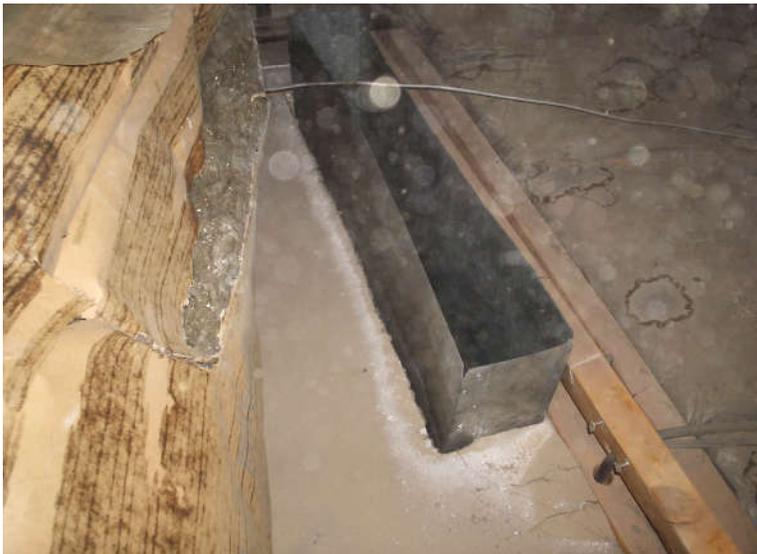
1: There should be an upper combustion air source. There is plenty of combustion air for the mechanical closet with the metal vent into the attic. However, a vent opening should be cut into the top 12" of the vent. The vent should be about 45 square inches in size. In the attic space, the combustion air vent top was partially covered with insulation. **Photo 11.** The insulation should be kept off of the top of the metal combustion air vent.

11 The combustion air vent is partially blocked by insulation in the attic space.

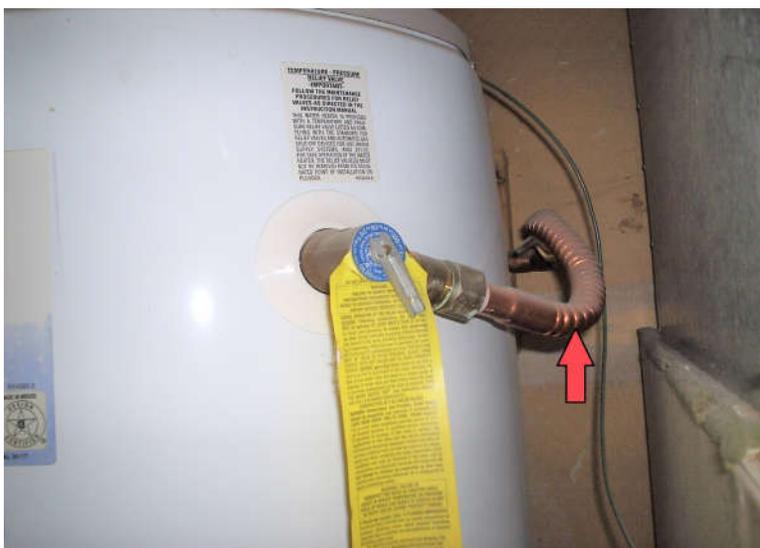
1: The relief valve piping for the water heater should not go uphill at any point. It should slope downhill away from the relief valve. **Photo 12.** If the relief valve does go uphill, a drain petcock should be installed at the lowest point.

12 The pipe from the water heater relief valve should not go uphill or create a trap.

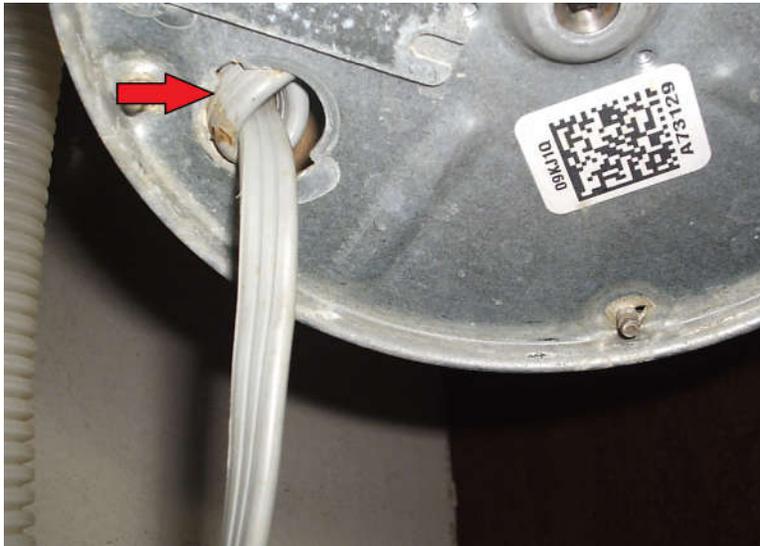
13 The connector clamp is not present on the disposal power cable.

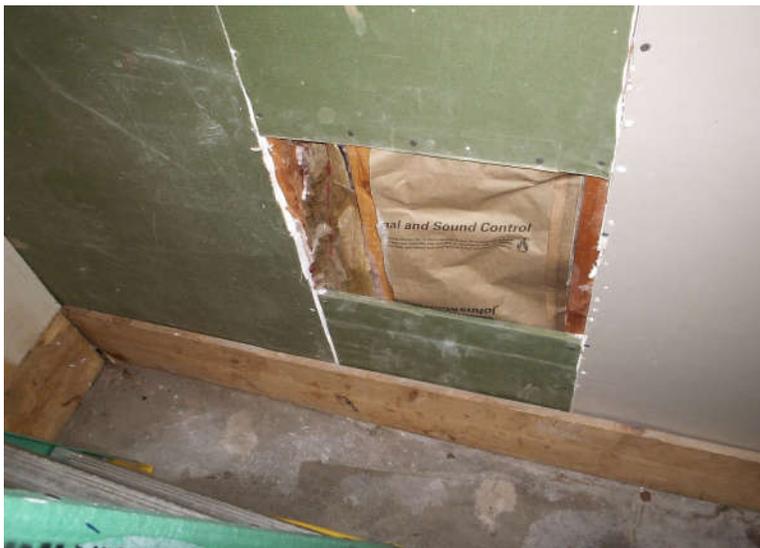
2: The wall areas that have living space on the other side should be protected with 5/8" Type X sheet rock. The seams in the wall material should be sealed with joint compound and tape. The missing panels of gypsum board should be replaced. **Photo 14.**

This is to prevent carbon monoxide from entering the house, and to create a fire break between the garage and the house. This is also to prevent or delay a fire from starting in the garage and spreading into the house. I recommend that you contact a qualified contractor to determine the proper corrective measures.

14 The seams and gaps in the gypsum board garage wall covering should be repaired.

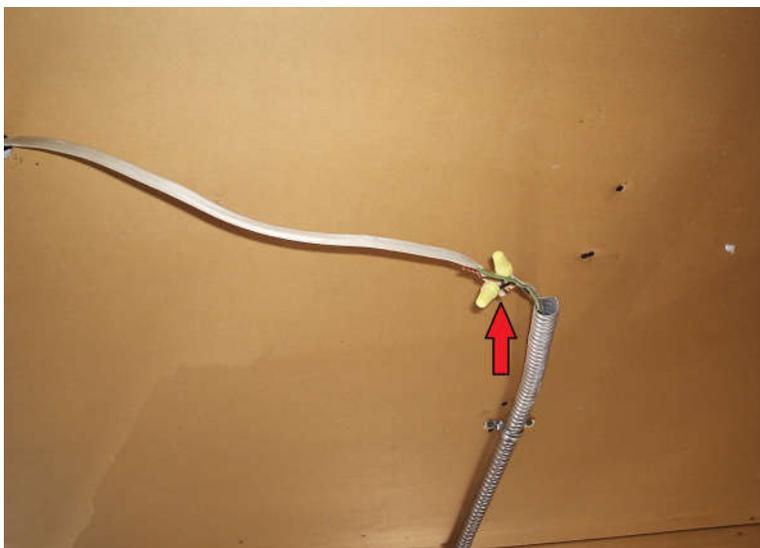
Safety Note: The wire splice for the overhead lights should be in a covered junction box. **Photo 15.** I recommend that you contact a qualified electrical contractor to determine the proper corrective measures.

15 The wire splice for the garage overhead lights should be repaired.
